Restoring the Salmon River Estuary

Journey and Lessons Learned Along the Way 2006 - 2014

Authored by
Kami S. Ellingson, M.F. - Hydrology and
Barbara J. Ellis-Sugai, PhD.

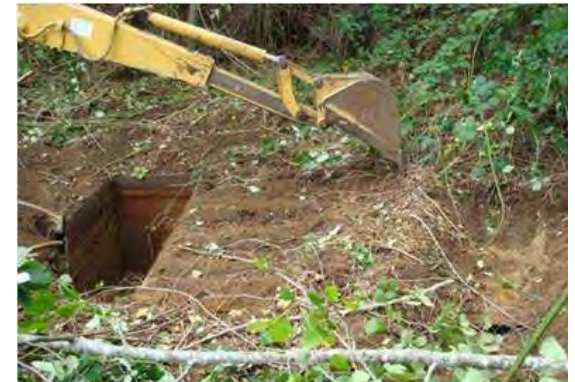
The septic tank (*Figure 24*) was made of cinder block and measured 12 feet wide, by 26 feet long, by 12 feet deep and was covered with a thin, rusted piece of sheet metal. With equipment standing by, we located the tank by measuring from a known junction box.

Figure 24. Decommissioning failed septic tank.

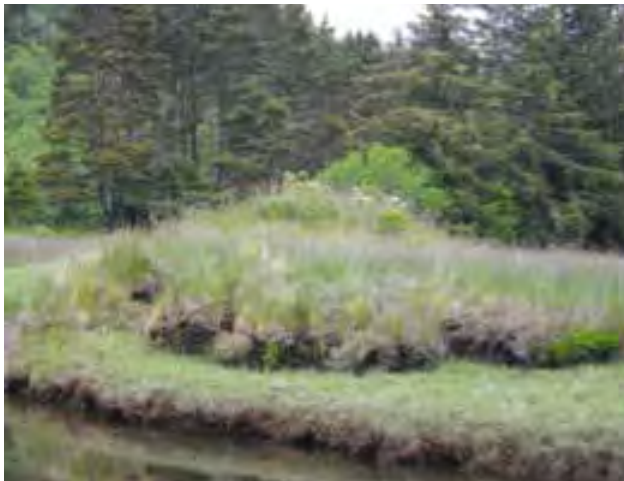
Figure 59. August 2012 prior to the removal of the dike. The view shows the end of the dike near the mouth of Crowley Creek looking upstream.

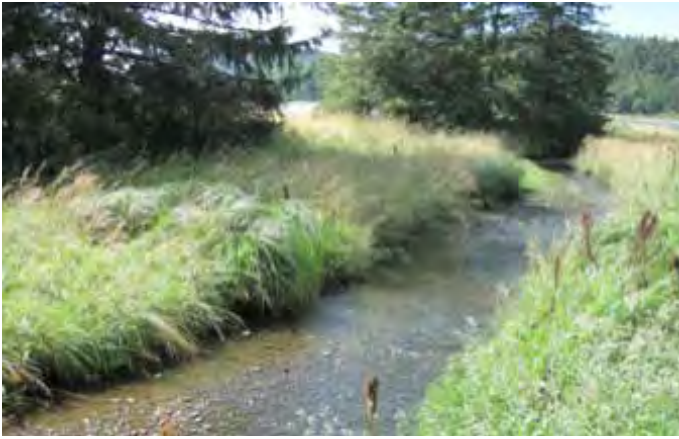
Figure 62. Looking across Crowley Creek at the spruce trees growing on the dike.

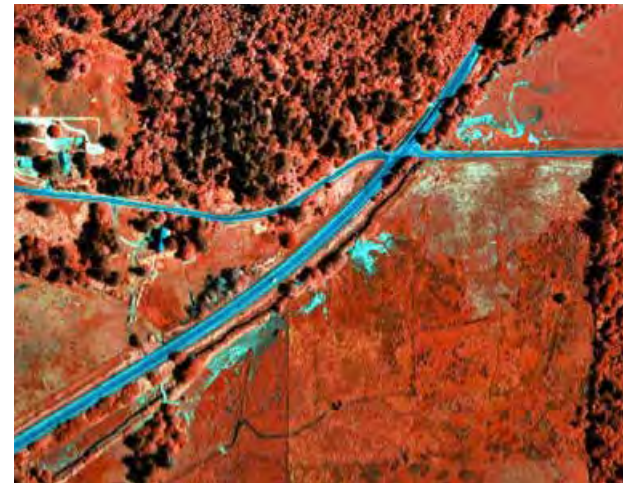
system. Currently, Salmon Creek is forced into a straight line, any gravels moving down Salmon Creek deposit and fill the Salmon Creek ditch. This causes it to fail during high flow events. Additional work may include reconnecting Salmon Creek with the remnant channel northwest of U.S. Highway 101 by building a bridge, or other crossing at U.S. Highway 101. Making these changes will restore the valuable salinity gradient that anadromous fish in this system are seeking and rely on to aid in their transition from fresh to salt water. For this to occur it is important the tidal channels are connected to their fresh water sources.

Figure 84. Berm breaks – Color infrared photo (2000) shows breaks in the berm (aqua color) along the Salmon Creek ditch.

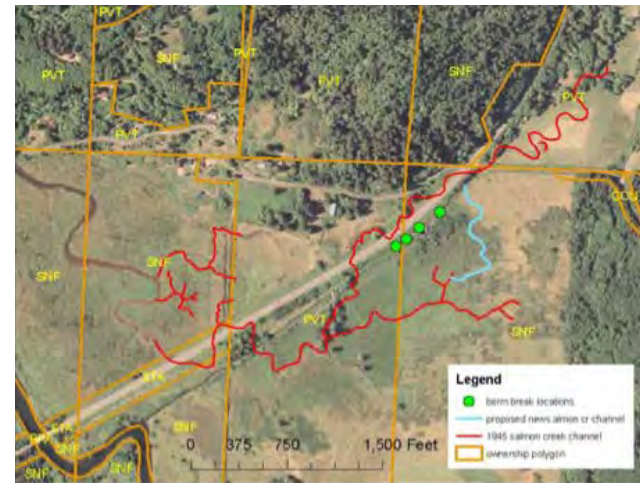
Figure 85. This is the design concept for a new channel which will bypass the breaks in both the ditch and the berm along U.S. Highway 101. The red line is the historic location of Salmon Creek prior to the construction of U.S. Highway 101 in 1961. The blue line is an approximate location for a new meandering channel for Salmon Creek. It would bypass the berm breaks (green dots).

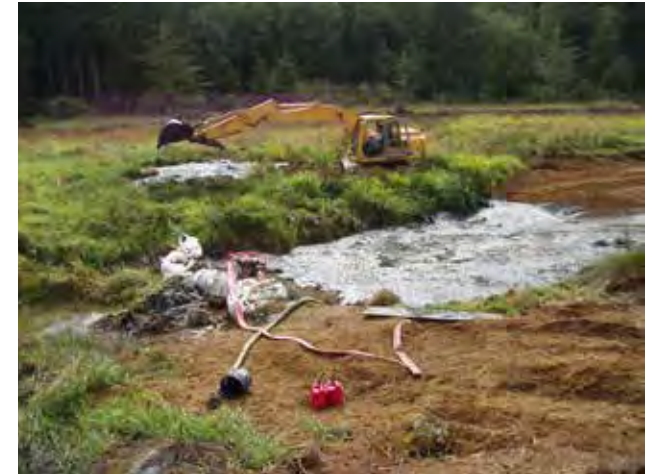
In some instances, to speed up the work, the black goo was dug out of the ditches or ponds and placed on upper ground surfaces where it was allowed to dry out. The ponds or ditches were then filled with dry fill material and graded. The piles of black goo that were dug out of the ditches were then graded and mixed into the new marsh surface. This method wasn't as satisfactory as leaving the black goo in place. The goo still had to be allowed to dry out and graded into the marsh surface at Pixieland. If time had been available, it would have been better to allow the black goo to dry out in place.

Figure 93. The black goo, or marsh muck, collected behind the coffer dam in the ditch. As the fill was added it pushed the muck toward the end of the ditch. The excavator operator used the bucket to scoop out the muck and place it on the marsh floor behind the excavator.

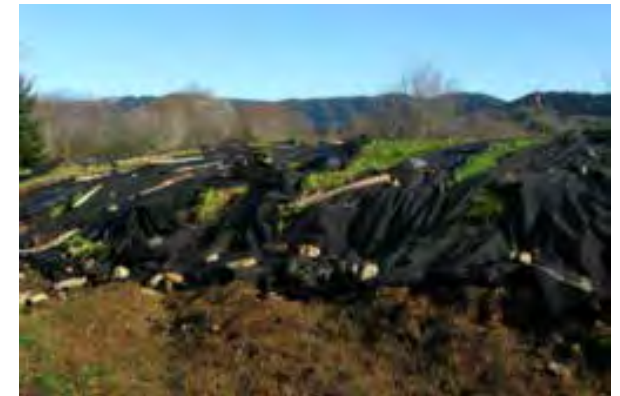
We learned if it was taken off site, it would have to be disposed of in a landfill that could handle hazardous waste. The cost to do this, approximately \$80,000, was prohibitive. We sought advice from other wetland restoration specialists. The solution was to pile it in a mound in the upland meadow area adjacent to the trailer park where the septic system had been. Then it was covered with landscape cloth. Early in the following winter, it quickly became apparent that stakes, sandbags and chunks of large logs were not sufficient to hold down the cloth in a windy area. In the fall of 2010 the whole mound with the landscape cloth was covered with approximately six inches of mulch. In the future, the mound will be planted with native trees to shade out the grass.

Figure 96. Reed canary grass mound after the first winter. The grass is beginning to sprout in between the sheets of landscape cloth.
