Restoring the Salmon River Estuary

Journey and Lessons Learned Along the Way 2006 - 2014

Authored by
Kami S. Ellingson, M.F. - Hydrology and
Barbara J. Ellis-Sugai, PhD.

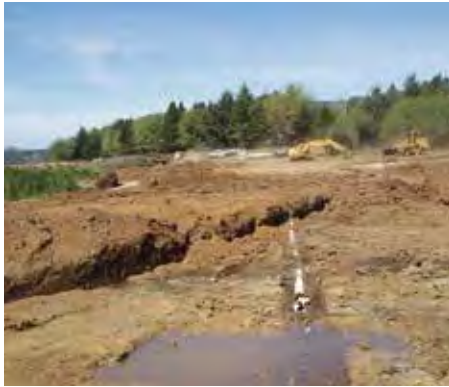
Figure 12. The exposed PVC pipe marks the original marsh elevation. Fill removal is in progress in the background.

In 2007 the restoration work focused on clearing the site of any remnant infrastructure from the trailer park. This included decommissioning a long-failing septic system and removing concrete trailer pads and asphalt roads. The clean-up work continued in 2008 when it mainly focused on removing underground utilities (*Figure 12*).

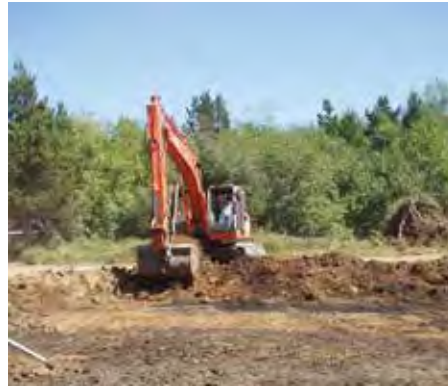
Figure 13. Removing fill from the buried marsh floor. Note the dried grass that was uncovered in the foreground, which confirms the original marsh surface has been uncovered.

The majority of the restoration work was done in 2009. The marsh surface adjacent to Rowdy Creek was exposed for the first time since the late 1960s and fill material, approximately three feet deep, was removed (*Figure 13*).

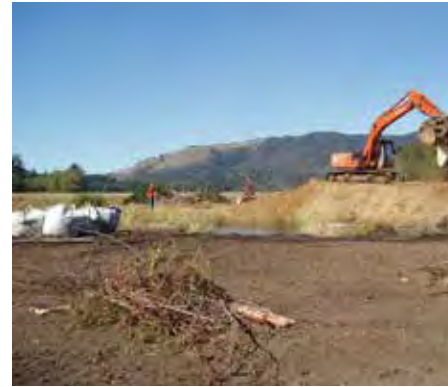
Figure 14. Removal of the final portion of dike that surrounded the development.

The dikes, dam and lower tide gate were removed. This connected the area to the rest of the estuary (*Figures 14, 15 & 20*). *Figure 21* is a photo just after the tide gate was removed. *Figure 22* depicts the same location three years later with a returning king tide. Ditches were also filled in. In addition to the earthwork, two wells were

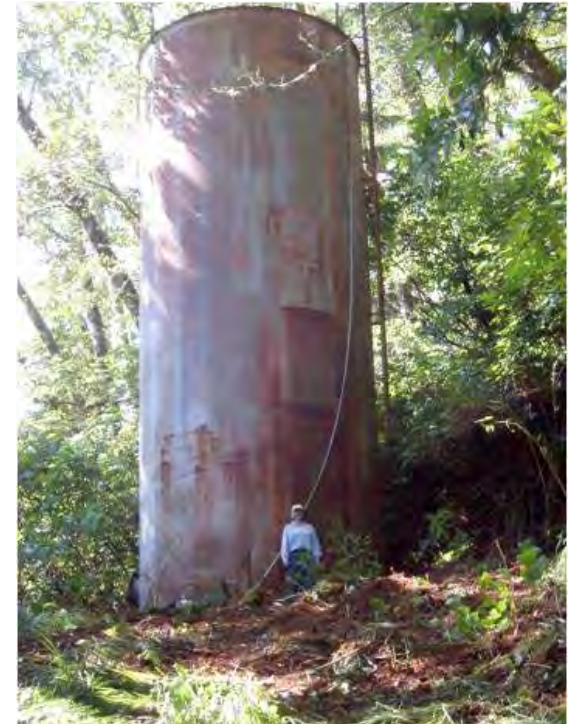
Figure 23. 35 foot water tank for gravity-fed drinking water system.

The water tank (*figure 23*) was welded in place in seven foot sections, measuring 35 feet tall. To decommission it, we had to build a crib downslope to prevent the tank from rolling when it was pulled over. The tank was flattened and recycled.

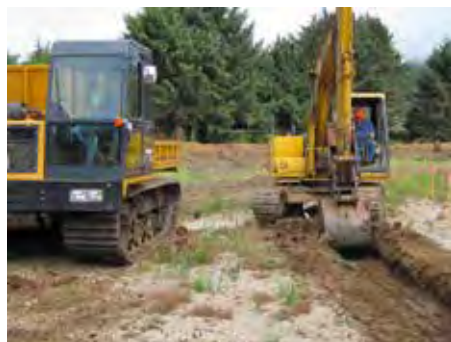
Figure 34. A small meandering stream channel was dug to provide natural drainage to the marsh surface.

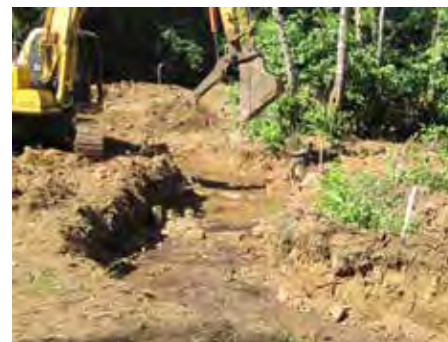
Figure 36. Digging the upstream portion of the new Fraser Creek channel just downstream of Highway 18.

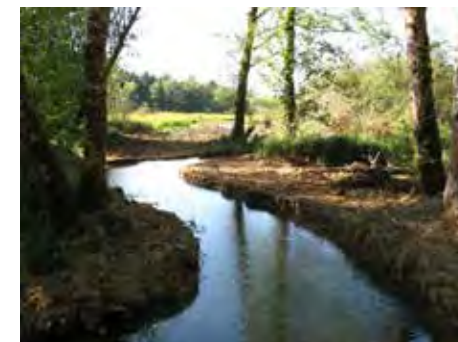
Figure 37. Finished Fraser Creek channel at a moderate high tide in September.

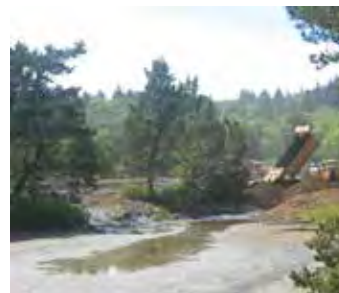
Figure 46. Filling interior ponds.

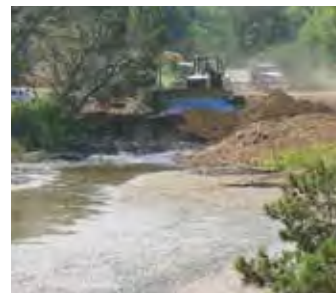
Figure 47. Filling interior ponds.

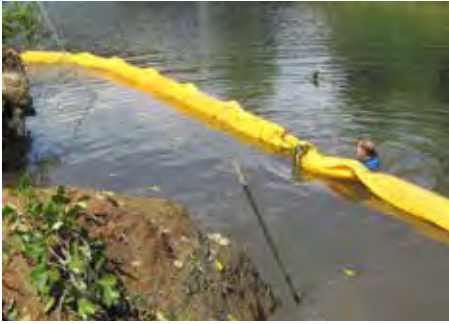
Figure 48. Installing the sediment curtain near the outlet of the tide gate in the Salmon River.

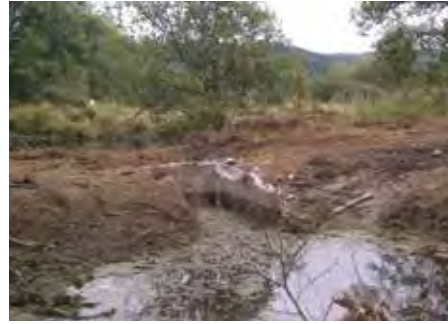
Figure 50. August 22, 2011 site prep for tide gate removal.

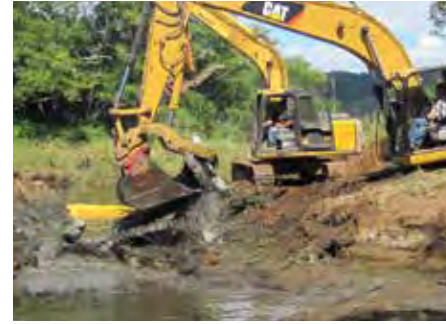
Figure 51. Removing the concrete around the tide gate, August 24, 2011. Jared Richey and Paul Lindsey pictured.

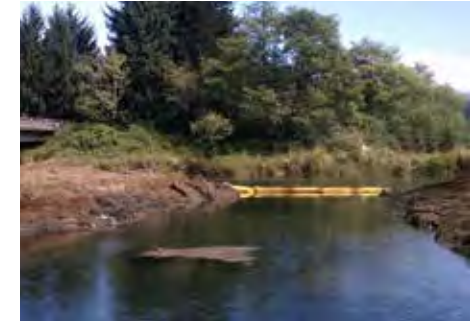
Figure 52. The morning after the tide gate was removed, August 25, 2011.

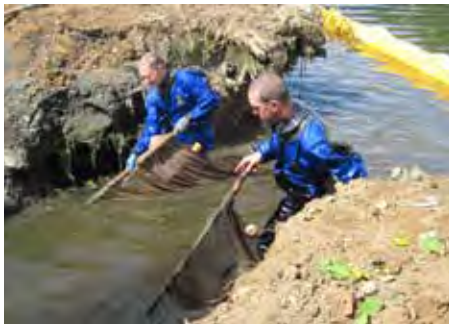
Figure 49. Last pass through waterway with seine net before remaining concrete is removed from tide gate area. Siuslaw National Forest Fisheries Biologists Jason Wilcox and David Skelton pictured.

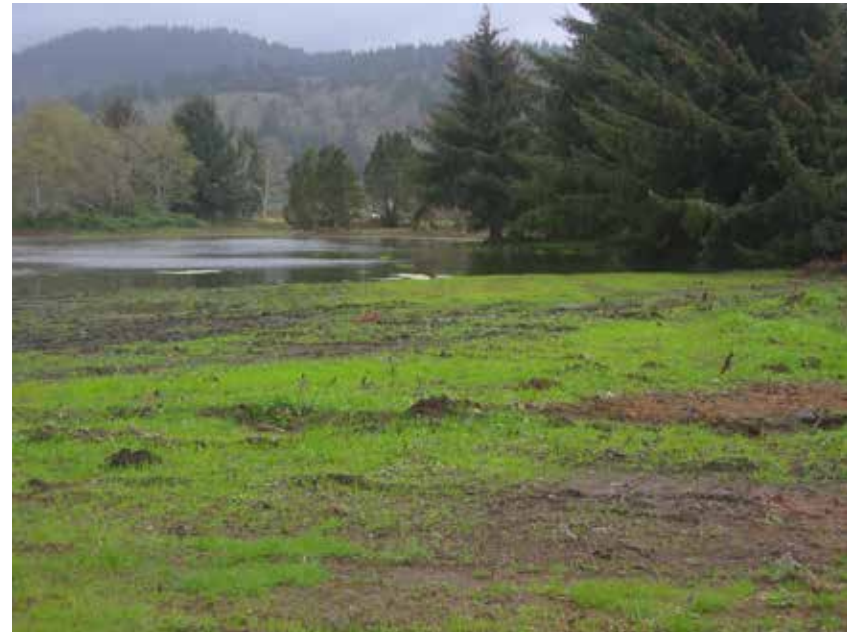
Figure 54. After: 2011, Main Street, Pixieland after restoration. This photo was taken in the same orientation as the 1969 photo (left).

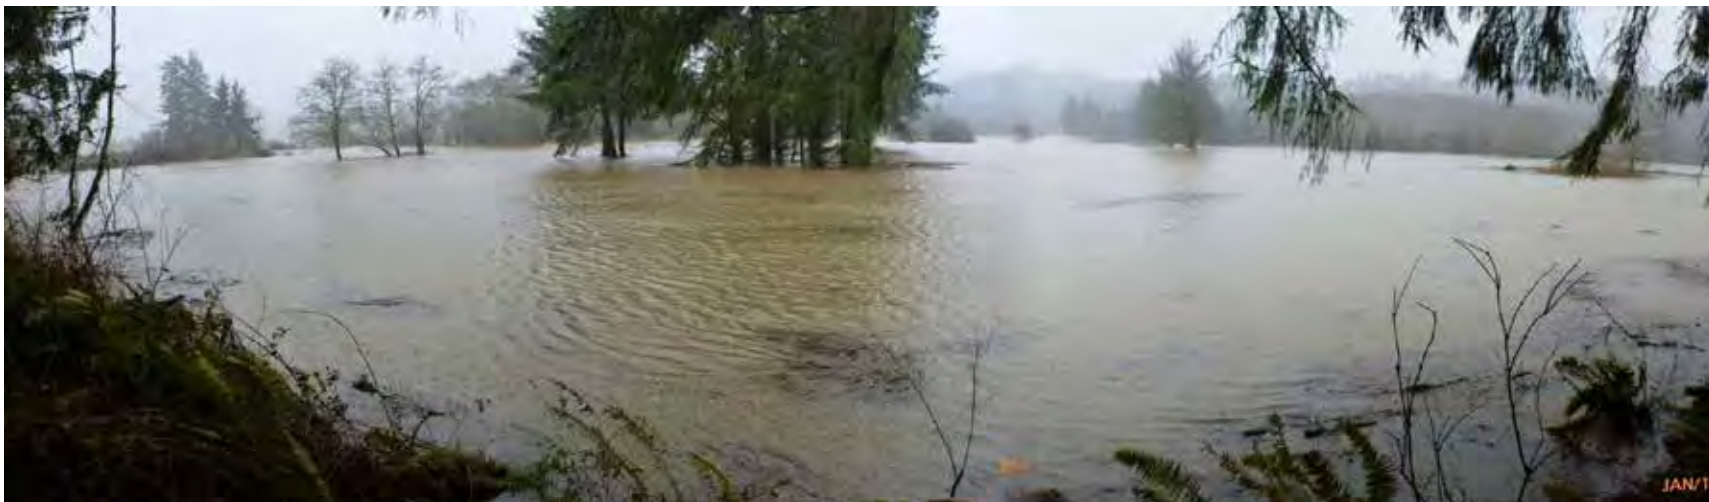
Figure 55. Restored Pixieland marsh with a ten-foot tide and a three-day rainfall event, January 19, 2012. View is from the shoulder of U.S. Highway 101 looking south-east. This photo shows the extensive flooding of the restored marsh.

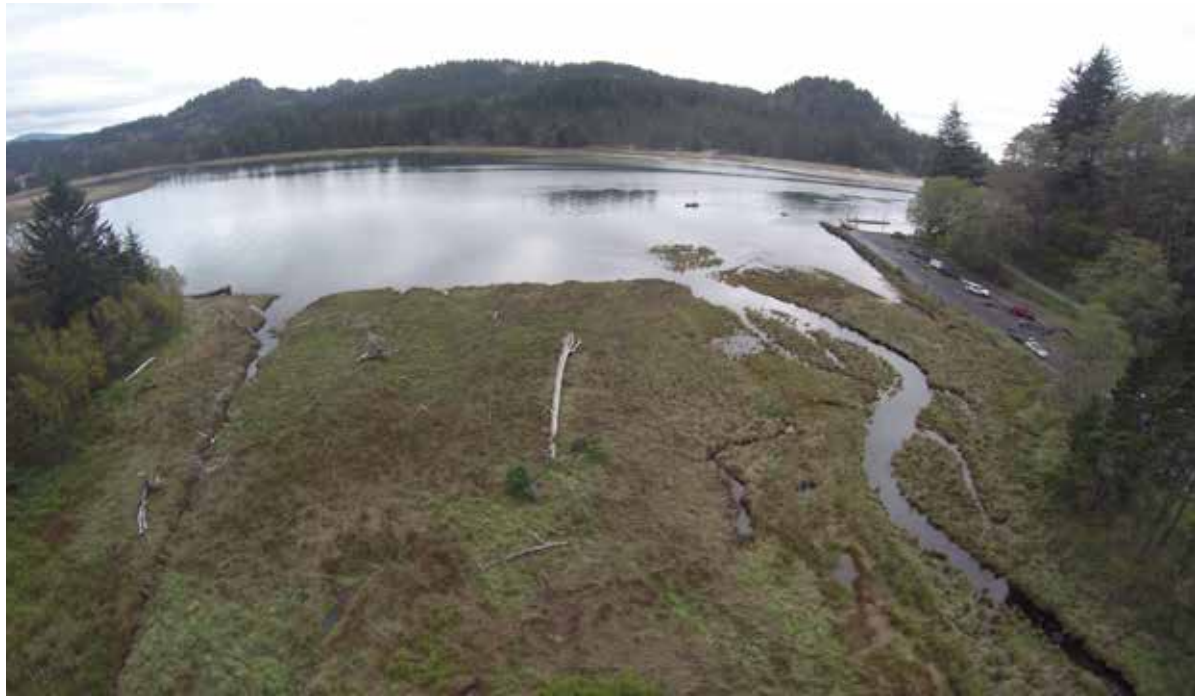
Figure 56. Braided channels of Crowley Creek following restoration. October 10, 2014.
Photo credit Grayson Lewis.

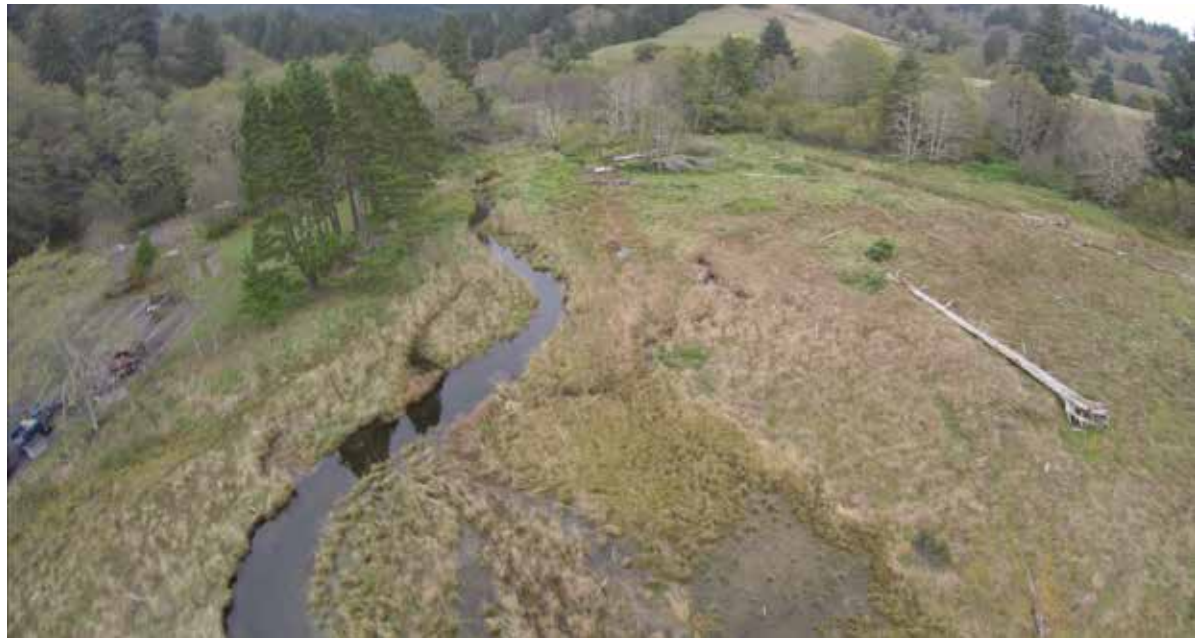
Figure 58. Aerial photo looking upstream at Crowley Creek following restoration. October 10, 2014. Photo credit Grayson Lewis

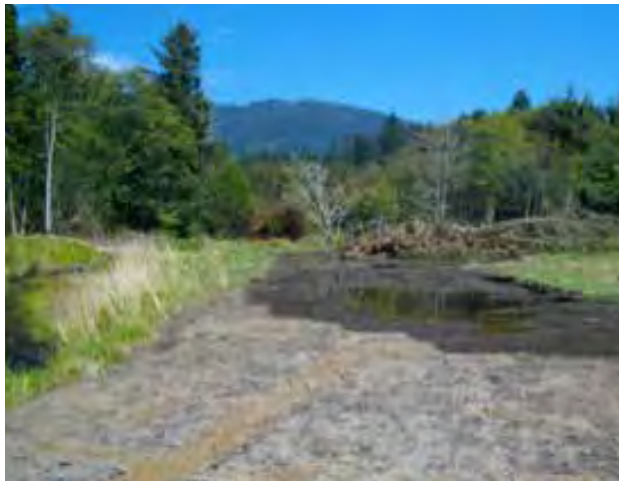
Figure 60. August 2012 immediately after the dike was removed. Crowley Creek is on the left side of the photo, view to the north. This photo was taken in September when streams and rivers are at their lowest flows and the ground is dry.

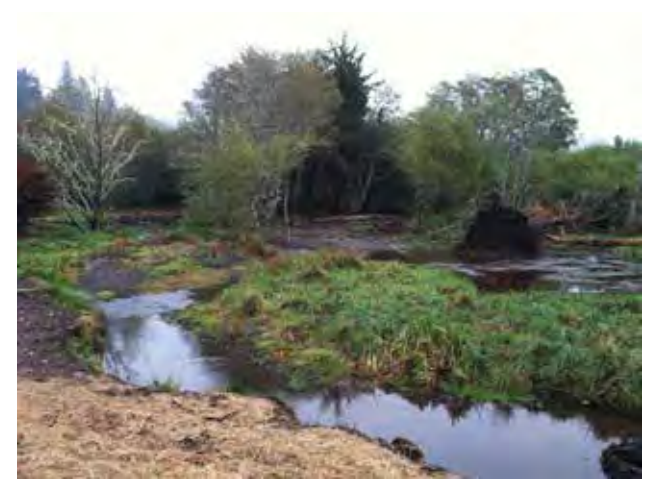
Figure 61. November 2012 looking across Crowley Creek. Restoration completed August 2012.

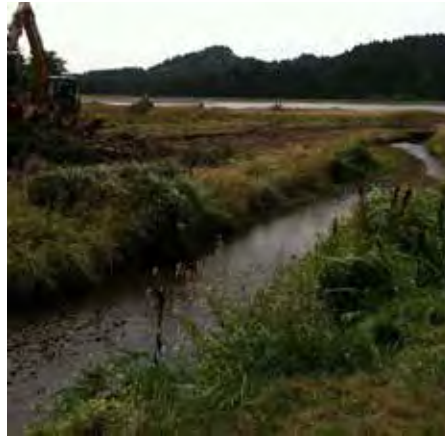
Figure 63. Excavator removing spruce trees and dike, freeing Crowley Creek from the ditch.

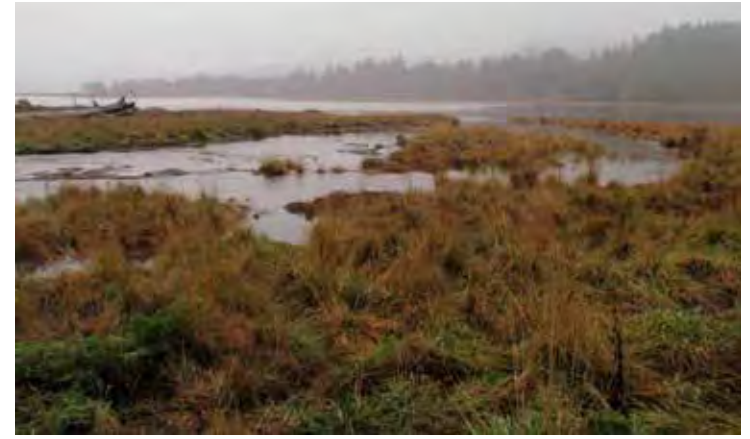
Figure 64. High tide at Crowley Creek after restoration. January 2013.

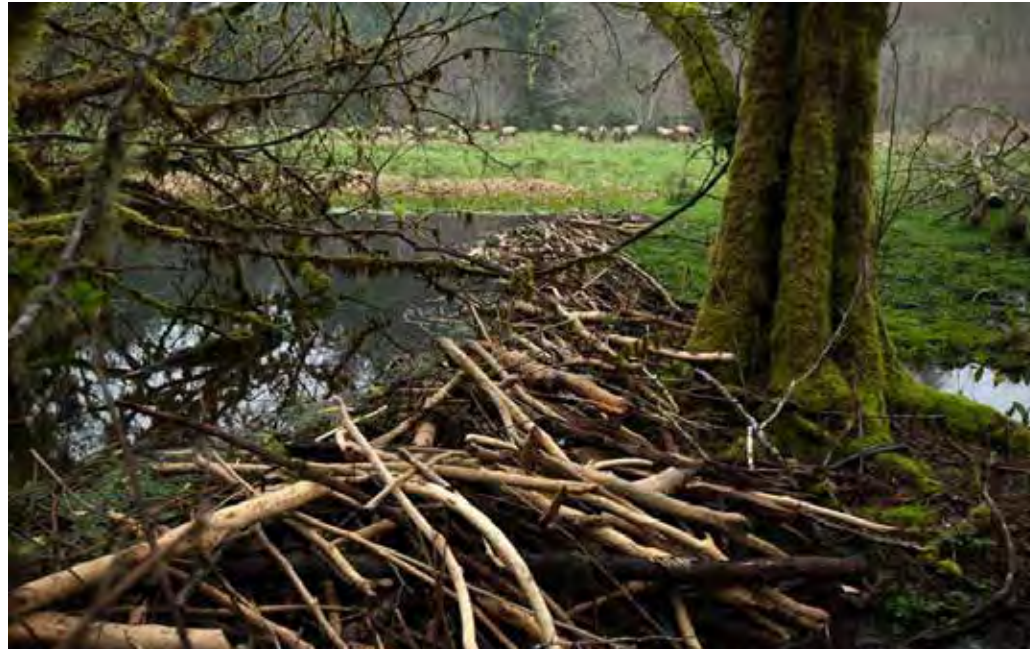
Figure 65. Beaver dam on Crowley Creek, upstream of Crowley Creek restoration project. Resident elk herd in the background. Photo credit Duncan Berry.

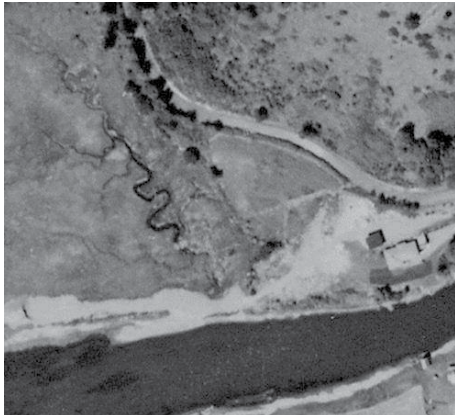
filled in, and the ground now occupied by the dammed pond to the west. The reason for this slight rise isn't obvious, but it kept Mink Creek in its own small watershed. Another reason this option wasn't considered was that the area around Mink Creek has been significantly altered. The boat basin ditch completely disrupted the local hydrology. It was carved through the slight drainage divide separating Mink Creek from the drainages to the west. It also captured other tributaries and changed their direction of flow (Figure 69). By the 1960s the mouth of Mink Creek had been blocked or altered (Figure 68).

Figure 68. 1961 aerial photo of the Mink Creek area. Mink Creek is the wide, meandering channel in the middle of the photo. Note the mouth of the creek appears to have a road crossing over it.

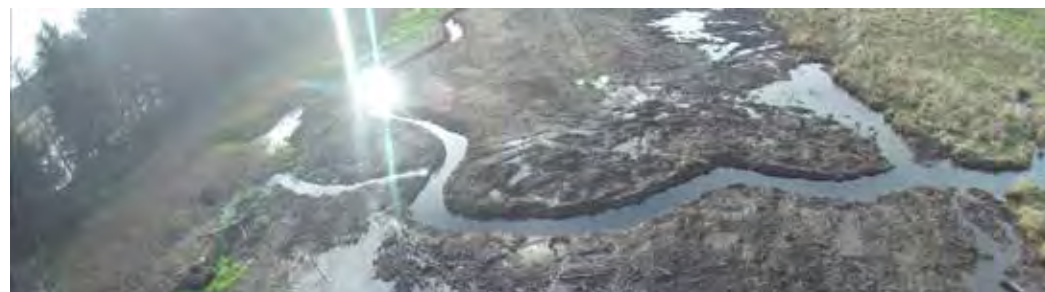
Figure 79. Aerial photo of Mink Creek and tributary channel during a receding 9.5 foot tide. October 10, 2014. Photo credit Grayson Lewis.

Next, we constructed a dam across the Boat Basin ditch and reinforced it with large woody material from the berm. The berm fill material was used to fill the ditch (Figure 73). Finally, we dug a new channel six feet wide for Mink Creek (Figure 71, 74-76 and 79). Figures 77 and 78 show the first incoming tide at 9:00pm on August 6, 2014.

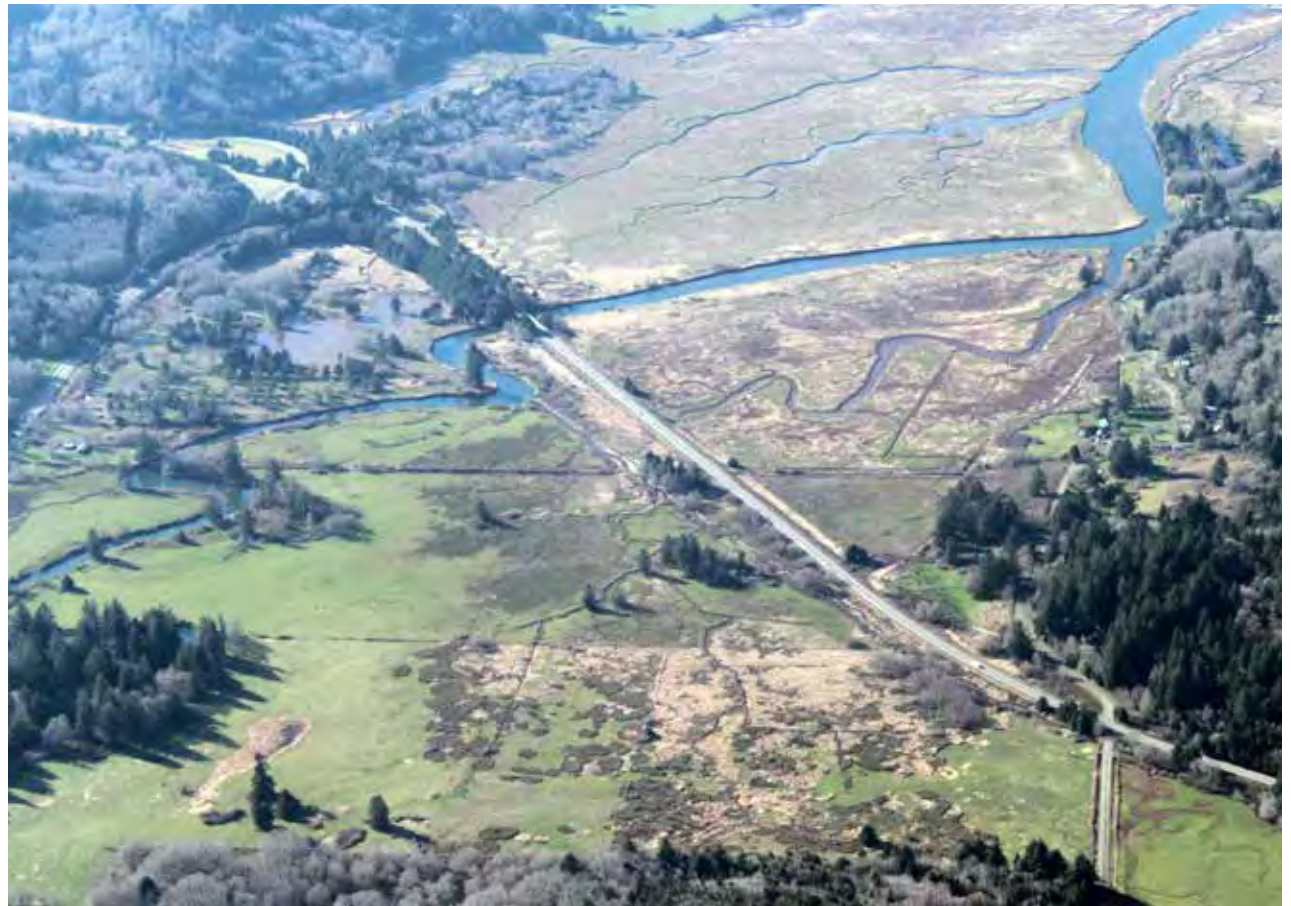
and Salmon Creek (north of the Salmon River) do not currently function as tidal or freshwater systems. Currently these altered channels do not provide the kind of salinity gradient that rearing salmonids need to make a successful transition from freshwater to the ocean. The remaining remnant channels on the west side of U.S. Highway 101 are dead end tidal channels which rise and fall with the incoming and outgoing tides. The channels of both Fraser Creek and Salmon Creek on the east side have been heavily altered by ditching, diking and tide gates (*Figure 80*). Fraser Creek was rerouted and split into two flow paths when Pixieland was built and tidal flow was controlled with a tide gate. Salmon Creek was placed in a ditch that has not been maintained. The ditch has filled with sediment and the creek breaches the ditch in several places during high water events.

Figure 80. 2011 aerial photo of U.S. Highway 101. Since 1961 Salmon Creek has been rerouted into the ditch (parallel to U.S. Highway 101). The historic Salmon Creek (to the right of U.S. Highway 101 and below Salmon River) is truncated by the highway. Photo credit Anthony Veltri.

We are currently pursuing ways to reconnect Fraser Creek and Salmon Creek with openings under U.S. Highway 101 to restore tidal inundation to the east side of U.S. Highway 101. Siuslaw National Forest secured approximately \$200,000 for a preliminary survey,

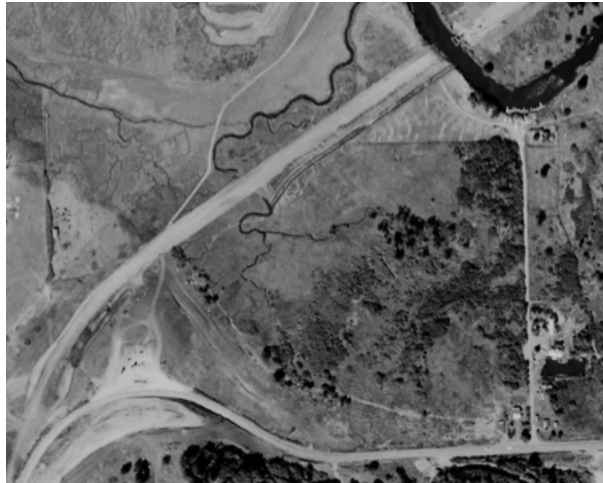
Fraser Creek was cut in two by U.S. Highway 101 and a ditch was dug parallel to the highway on the southeast side to connect the upstream portion of Fraser Creek to the Salmon River (*Figure 81*). The downstream section of Fraser Creek is just northwest of U.S. Highway 101 and was left as a remnant channel.

Figure 81. Fraser Creek was cut in two by U.S. Highway 101. A ditch was dug parallel to the highway on the southeast side to connect the upstream portion of Fraser Creek to the Salmon River. The downstream section of Fraser Creek is just northwest of U.S. Highway 101 and was left as a remnant channel.

Oregon Department of Transportation (ODOT) will build a crossing for Fraser Creek on U.S. Highway 101 during the summer of 2015. After the crossing is complete the Forest Service will fill the ditch emptying into the Salmon River.

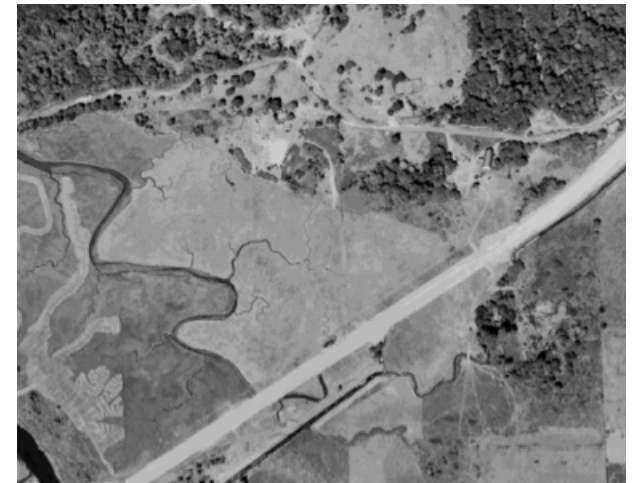
Background: Salmon Creek drains off the east side of Cascade Head. It was relocated into a ditch along U.S. Highway 101 when the highway was built in 1961 (*Figure 82*). A berm that was built along the ditch has breached in several places and fish are being washed out of the ditch into the meadow (*Figure 84*). The berm is on Oregon Department of Transportation's right-of-way.

system. Currently, Salmon Creek is forced into a straight line, any gravels moving down Salmon Creek deposit and fill the Salmon Creek ditch. This causes it to fail during high flow events. Additional work may include reconnecting Salmon Creek with the remnant channel northwest of U.S. Highway 101 by building a bridge, or other crossing at U.S. Highway 101. Making these changes will restore the valuable salinity gradient that anadromous fish in this system are seeking and rely on to aid in their transition from fresh to salt water. For this to occur it is important the tidal channels are connected to their fresh water sources.

Figure 82. 1961 aerial photo of U.S. Highway 101 under construction. Salmon Creek has been relocated into newly constructed ditches.

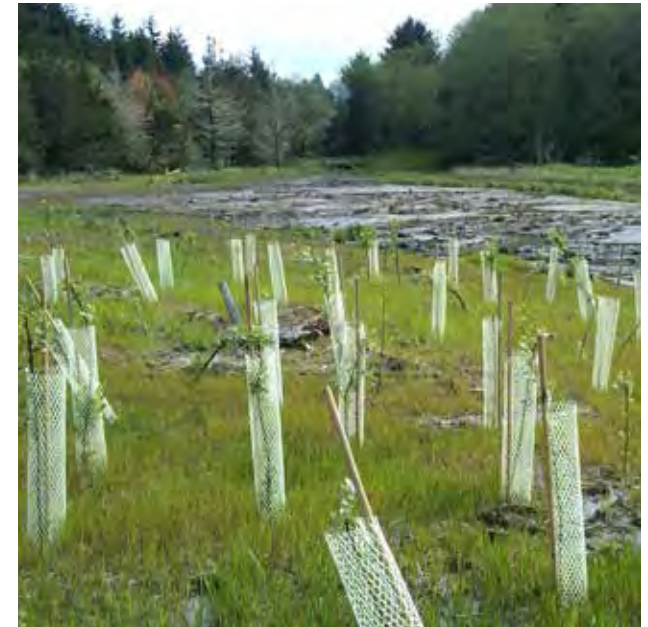
The willow survival seemed to be better away from the edge of the creek. Many of the surviving cuttings were in poor condition; some only had new leaves near the base. This may be related to the timing and condition of the original plantings or to the environment where this was observed. The condition after the next growing season should be more informative.

Figure 95. Tubed willow in the foreground at Tamara Quays.

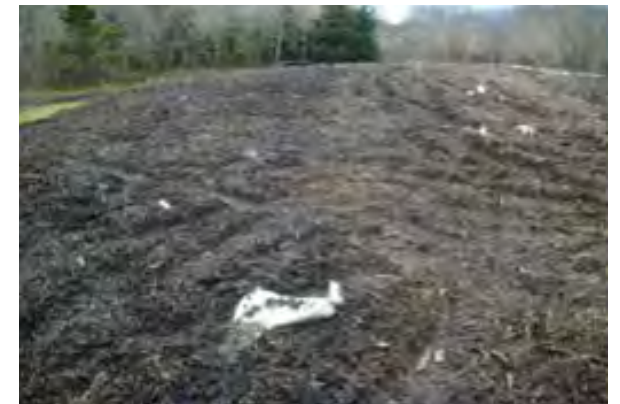
At Tamara Quays, approximately a quarter to a third of the fill removed from the restored marsh areas was reed canary grass sod (Figures 96 and 97). As the earthwork began in the summer of 2009, it quickly became evident that disposing of the sod would be a problem.

Figure 97. Reed canary grass mound after the second winter. The layer of mulch has successfully held down the landscape cloth.

We learned if it was taken off site, it would have to be disposed of in a landfill that could handle hazardous waste. The cost to do this, approximately \$80,000, was prohibitive. We sought advice from other wetland restoration specialists. The solution was to pile it in a mound in the upland meadow area adjacent to the trailer park where the septic system had been. Then it was covered with landscape cloth. Early in the following winter, it quickly became apparent that stakes, sandbags and chunks of large logs were not sufficient to hold down the cloth in a windy area. In the fall of 2010 the whole mound with the landscape cloth was covered with approximately six inches of mulch. In the future, the mound will be planted with native trees to shade out the grass.

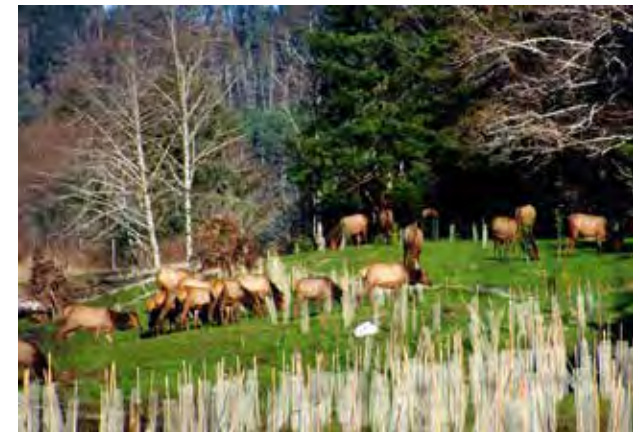
Browsing by elk (*Figure 98*) and deer should also be considered. Trees, especially cedar seedlings, may be heavily browsed and may need to be protected with wire cages until they are established. In areas that will be planted with native trees and shrubs, don't spend money on planting native grasses. If a cover crop is needed for erosion control, consider using annual rye, or something equivalent. Native plants that will readily seed into the site do not need to be purchased and planted. Alder is a good example. Mature alder trees were present on both sites adjacent to disturbed areas, and have seeded in on their own.

Figure 98. Resident elk herd pulling up planted spruce trees. This site required additional maintenance to ensure planting success due to the elk.

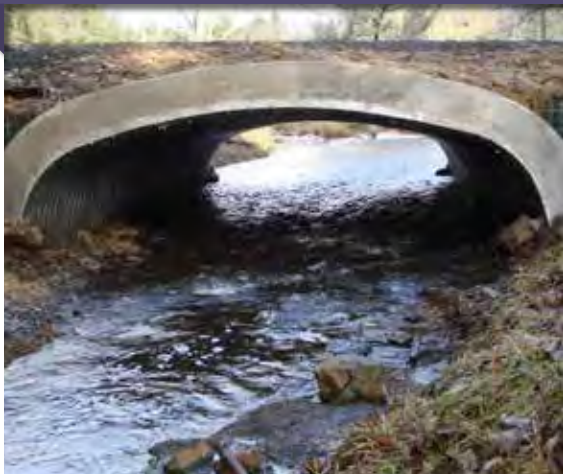
Figure 101. New Rowdy Creek culvert, built in 2008.

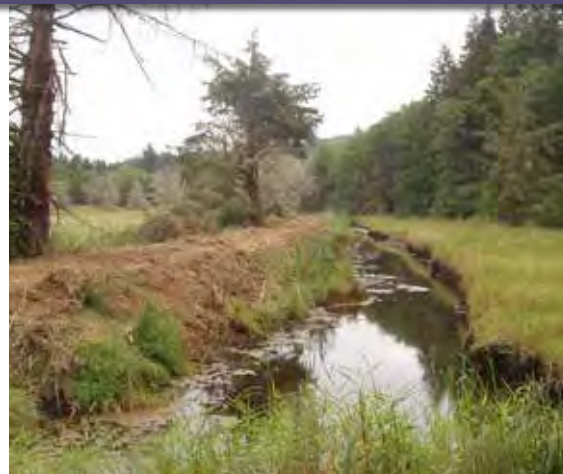
Figure 102. The dike and ditch on the west side of the Tamara Quays site prior to earthwork.

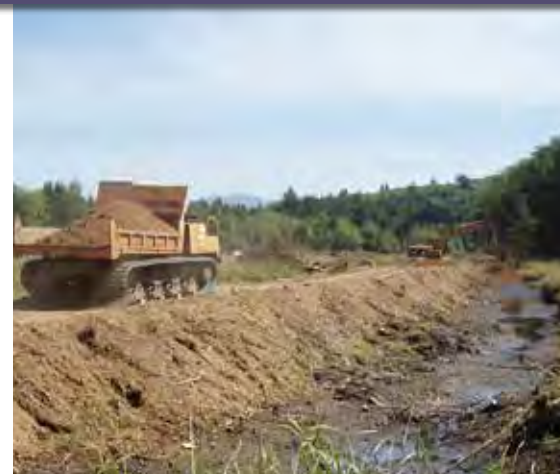
Figure 103. Work in progress on the dike and ditch removal. The tracked dump truck is transporting fill material that will be placed in the ditch.

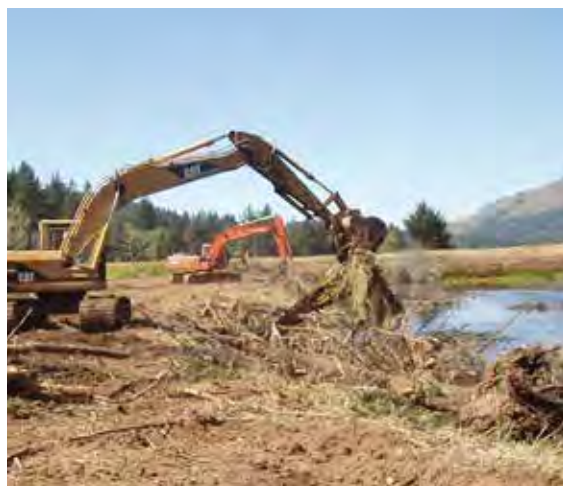
Figure 104. Placing large woody material along the edge of Kingfisher Lake for habitat enhancement.

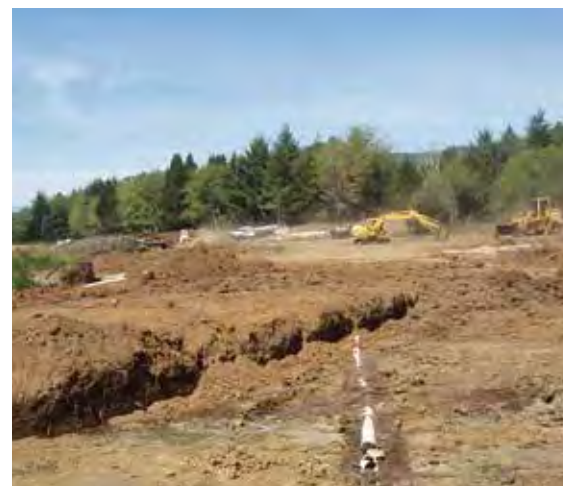
Figure 105. The exposed PVC pipe marks the original marsh elevation. Fill removal is in progress in the background.

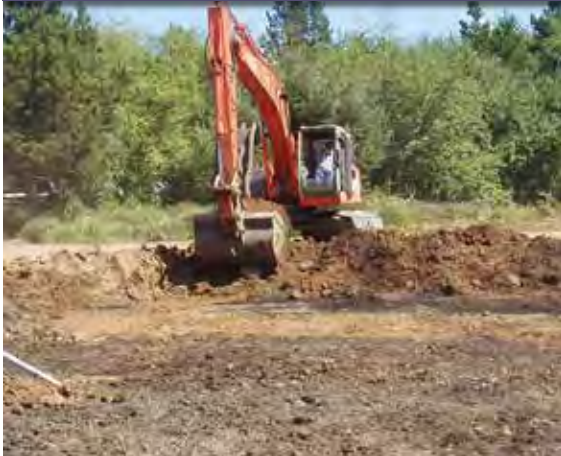
Figure 106. Removing fill from the buried marsh floor. Note the dried grass that was uncovered in the foreground, confirms the original marsh surface has been uncovered.

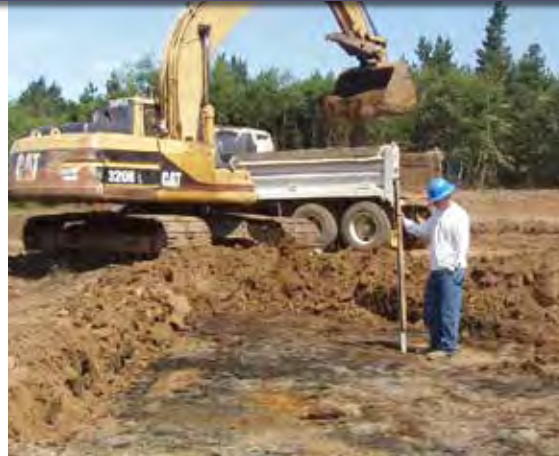
Figure 107. Using rod and laser level to check elevation levels during grading.

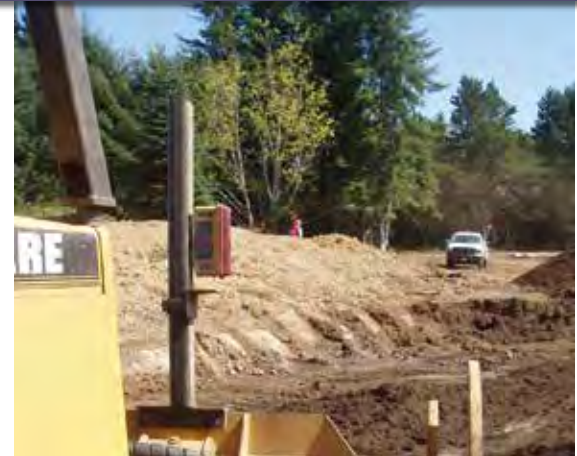
Figure 108. RA laser level eye was mounted on the blade of the bulldozer. This allowed for precise grading in an efficient manner.

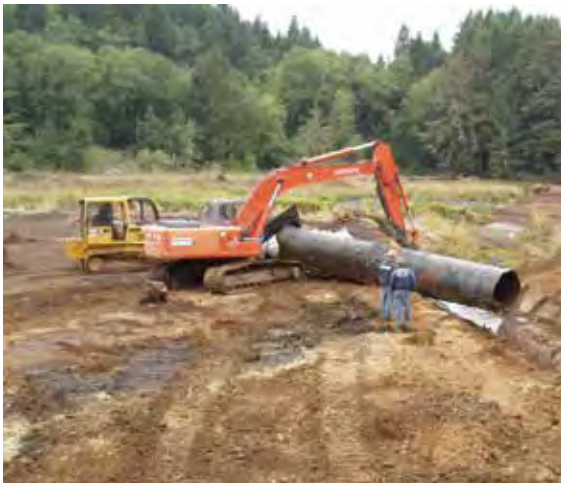
Figure 109. Removing the culvert at the tide gate.

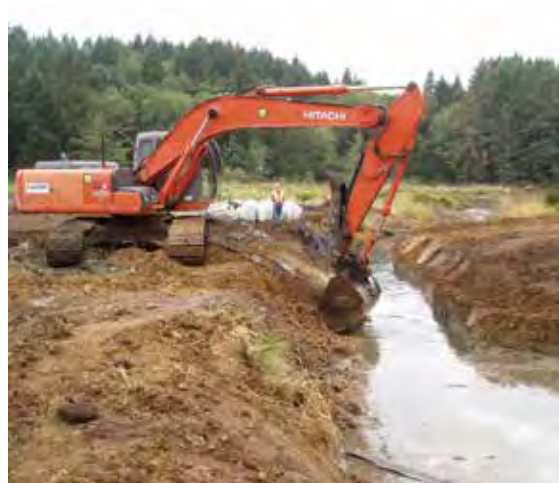
Figure 110. Shaping the stream banks after the culvert and tide gate were removed.

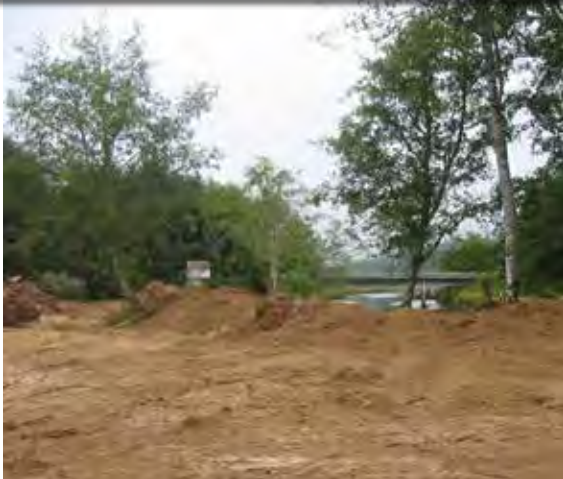
Figure 114. The dike along the Salmon River was cleared of vegetation, but is still present in this photo. The U.S. Highway 101 bridge over the Salmon River is in the background and the tide gate house is still standing.

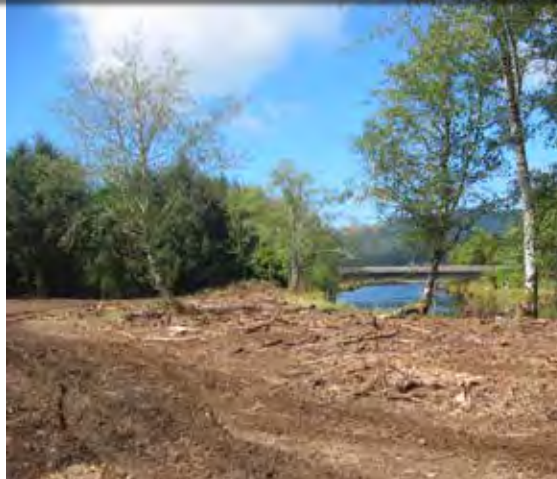
Figure 115. The dike has been removed and reshaped to resemble the natural levee present along other nearby sections of the river. The tide gate house is gone. Woody debris was scattered over the disturbed area.

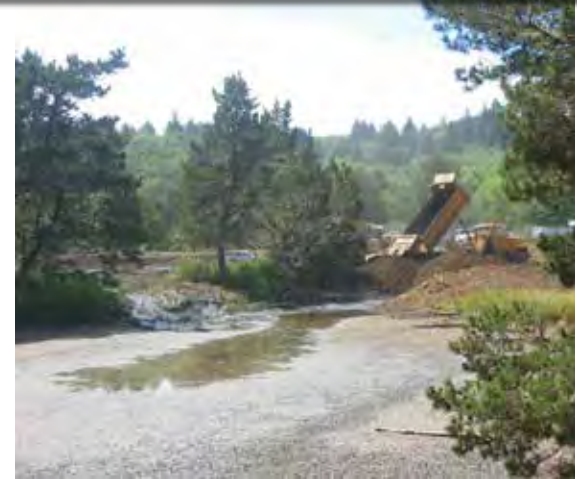
Figure 116. Filling interior ponds.

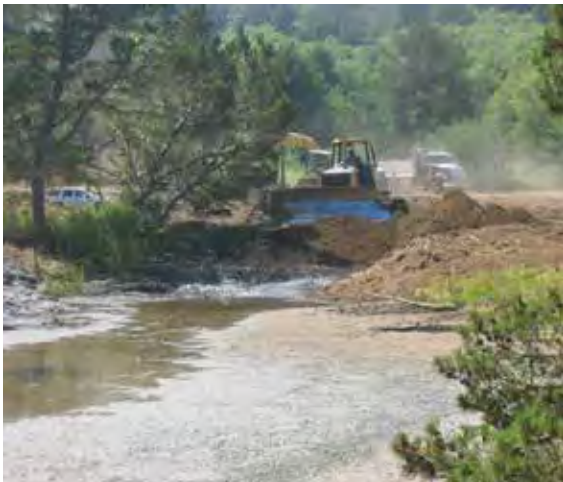
Figure 117. Filling interior ponds.

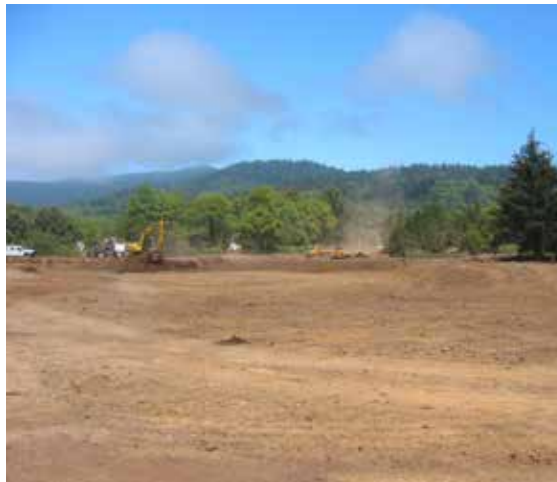
Figure 118. Removing fill from the restored marsh surface, work in progress.

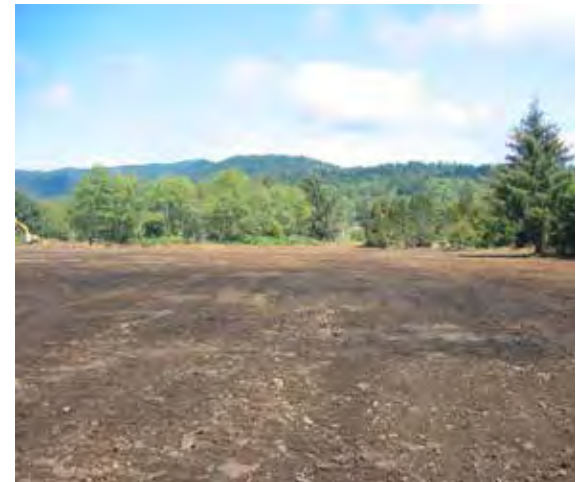
Figure 119. Finished marsh surface after the grading was completed. View to the north.
