Restoring the Salmon River Estuary

Journey and Lessons Learned Along the Way 2006 - 2014

Authored by
Kami S. Ellingson, M.F. - Hydrology and
Barbara J. Ellis-Sugai, PhD.

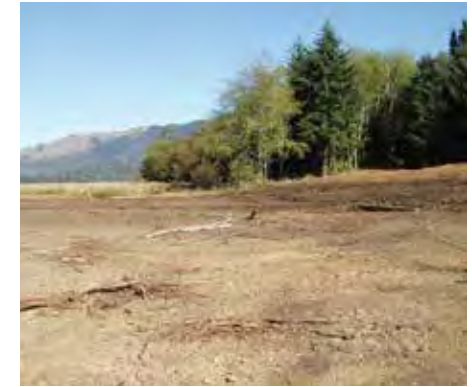
Figure 15. After removal of the final portion of the dike.

The dikes, dam and lower tide gate were removed. This connected the area to the rest of the estuary (*Figures 14, 15 & 20*). *Figure 21* is a photo just after the tide gate was removed. *Figure 22* depicts the same location three years later with a returning king tide. Ditches were also filled in. In addition to the earthwork, two wells were

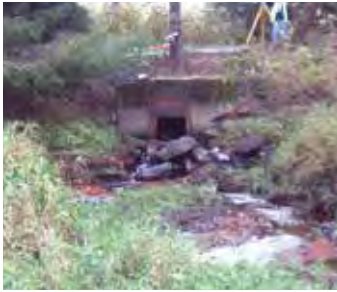
Figure 17

Figure 17. Upper tide gate on Rowdy Creek. (Red box in Figure A).

The main project in 2008 was replacing the undersized culvert and removing a tide gate which controlled freshwater entering the site. It also prevented fish movement (*Figure 17*). The culvert at the head of tide on Rowdy Creek under Fraser Road was replaced with a culvert which allows aquatic organism access to the upper portion of Rowdy Creek (*Figure 18*). *Figure 19* was

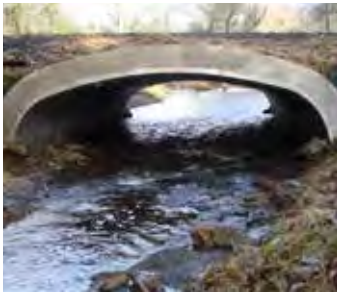
Figure 18

Figure 18. New open bottom culvert that replaced the tide gate on Rowdy Creek.

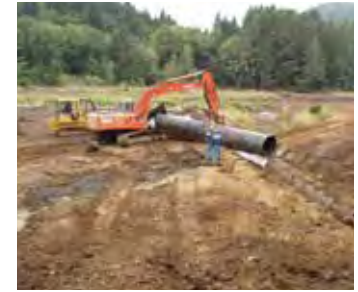
Figure 20

Figure 20. Removing the culvert at the tide gate at the lower end of the development. (Green dot in Figure 16).

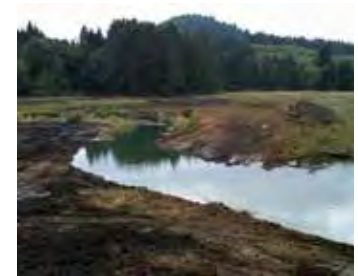
Figure 21

Figure 21. Rowdy Creek after the lower tide gate has been removed. (Green dot in Figure 16).

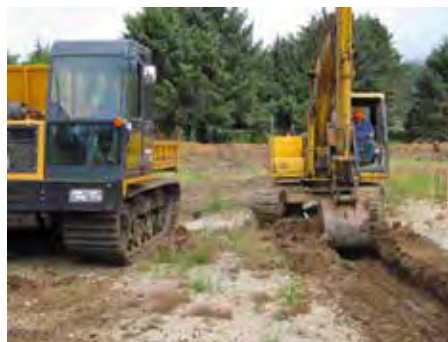
Figure 35. The small channel is finished.

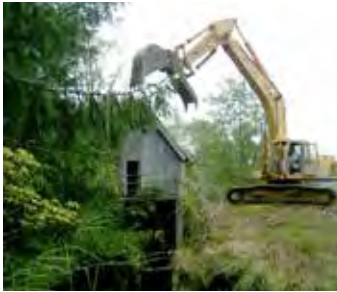
Figure 39

Figure 39. Last remaining Pixieland structure over tide gate.

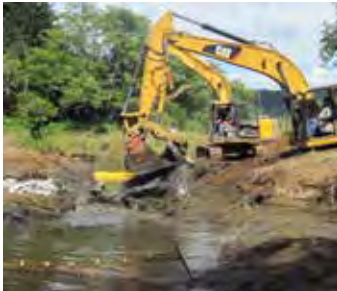
Figure 40

Figure 40. Structure and tide gate removal.

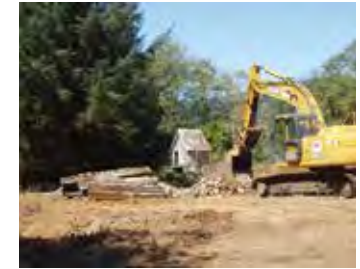
Figure 42

Figure 42. Removing concrete foundations from an old sewage treatment plant site near the tide gate.

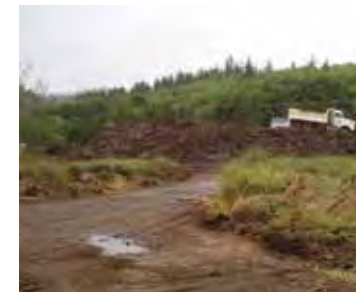
Figure 43

Figure 43. Pile of asphalt waiting to be recycled with a dump truck on top of it.

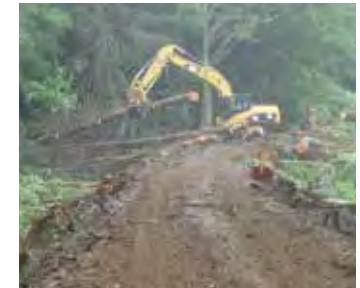
Figure 44

Figure 44. Removing trees from dike around Pixieland to facilitate its removal.

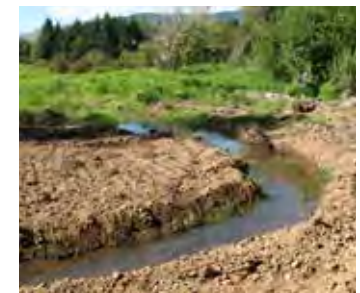
Figure 45

Figure 45. Fraser Creek tributary completed.

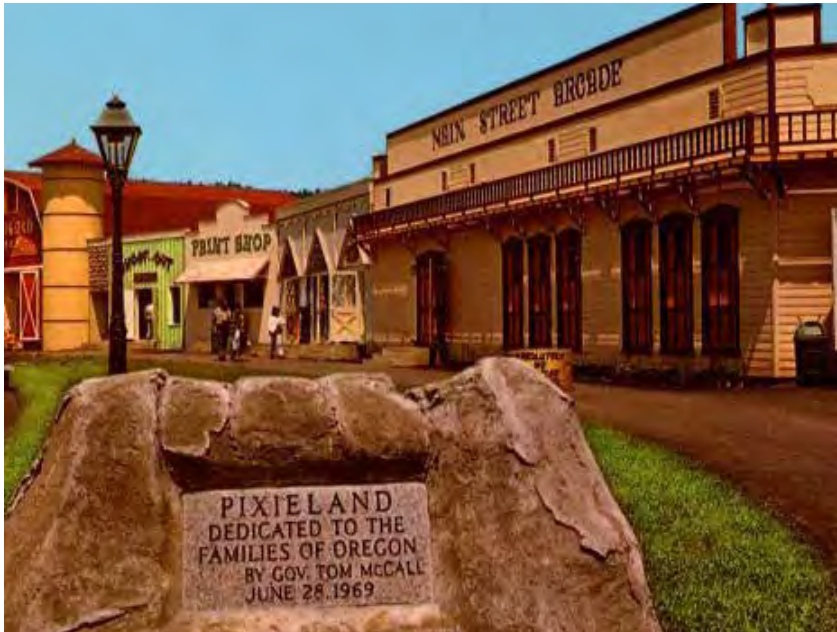
Figure 53. Before: 1969, Main Street, Pixieland when the amusement park was in operation.

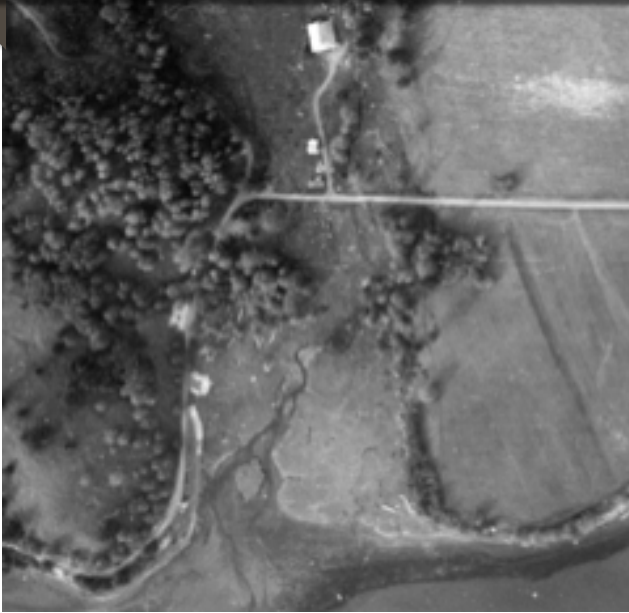
BEFORE

1939 aerial photo of Crowley Creek and surrounding area before any ditches and dikes were built.

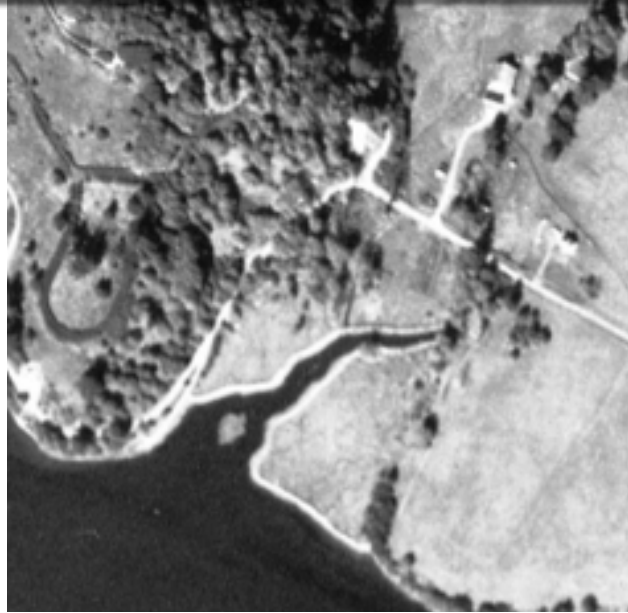
DURING

1952 aerial photo. Between 1944 and 1952 Crowley Creek and the marsh east of Crowley Creek had been diked.

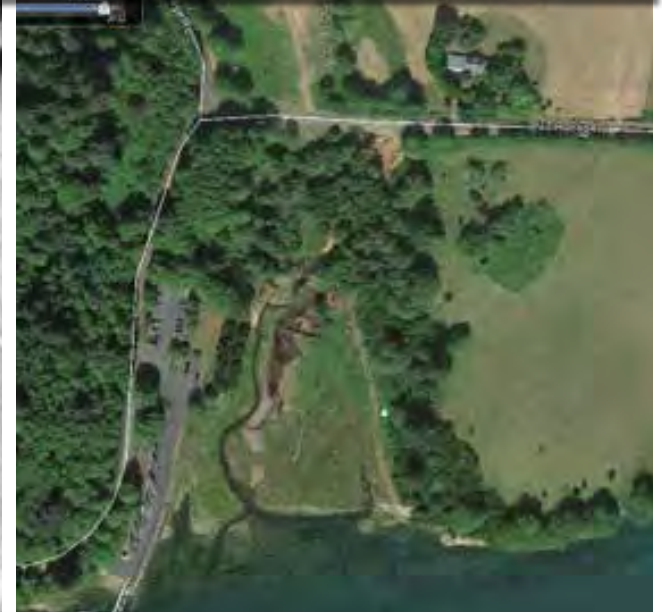
AFTER

2012 aerial photo of Crowley Creek area immediately after the dike removal.

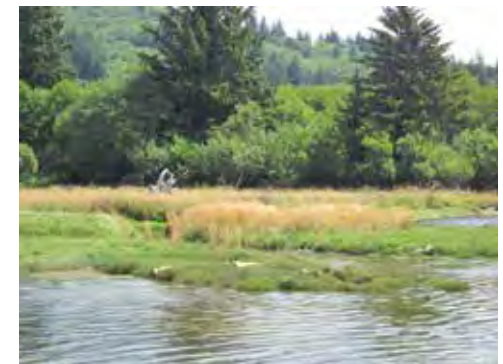
Figure 57. The mouth of Crowley Creek following restoration. September 2012.

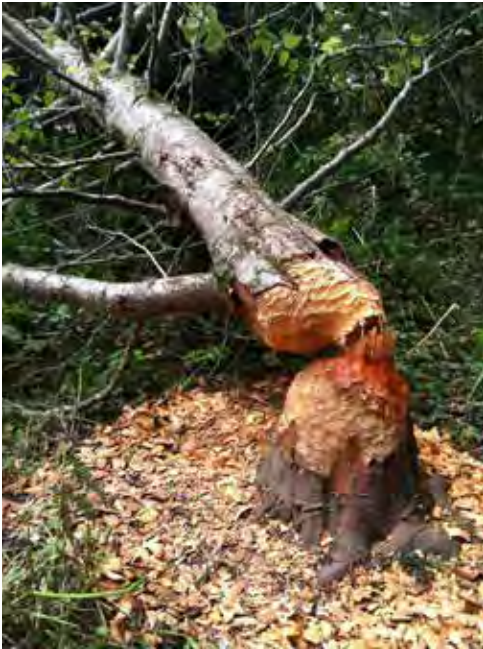
Figure 64. Industrious beaver helped with the restoration effort by felling trees during the night.

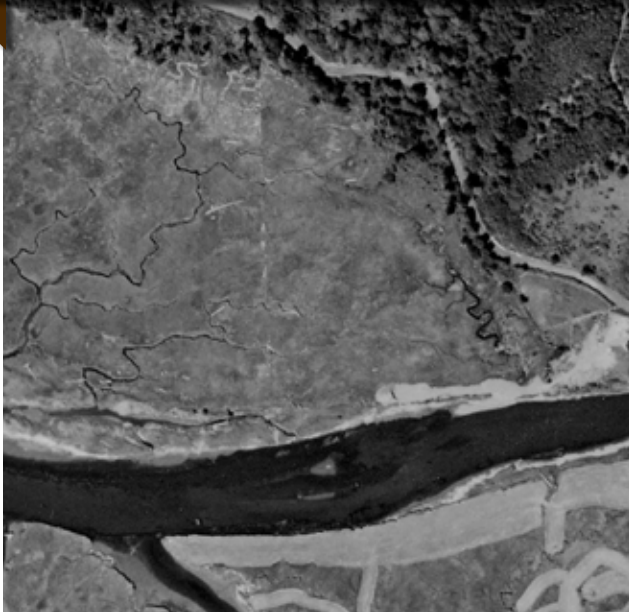
BEFORE

1961 aerial photo of the Mink Creek area. Mink Creek is the wide, meandering channel in the right of the photo. Note the mouth of the creek appears to have a road crossing over it.

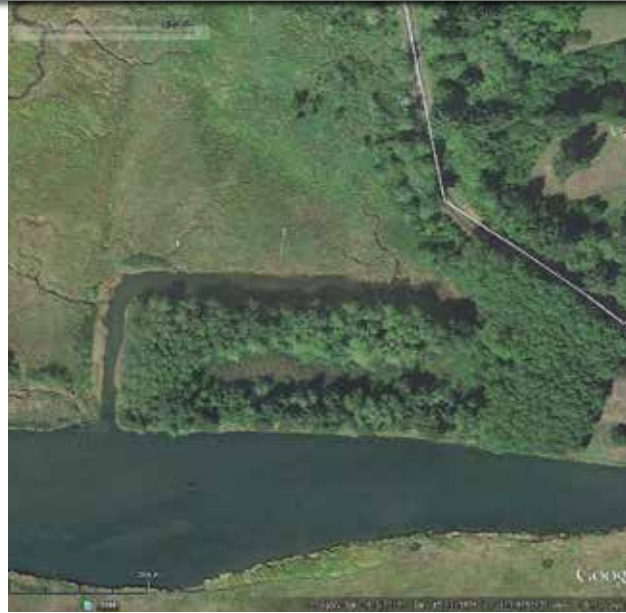
IN DEVELOPMENT

2005 aerial Google Image of the Boat Basin area.

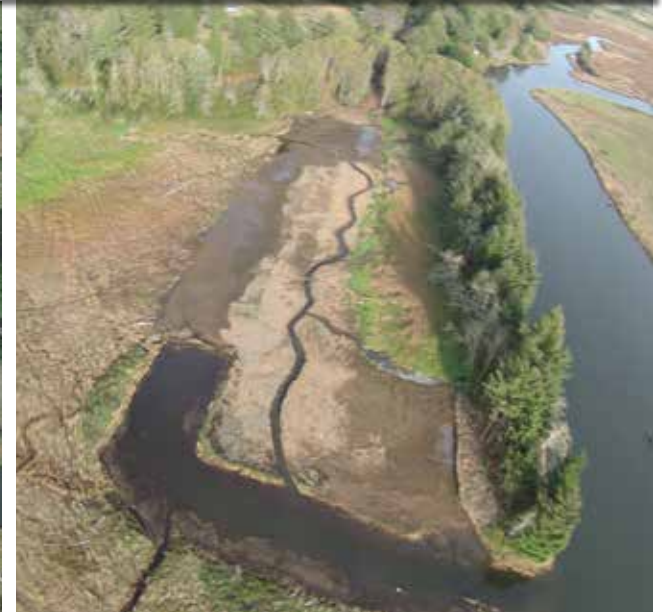
CURRENT

Aerial photo of the Boat Basin October 10, 2014, after restoration. Photo credit Grayson Lewis.

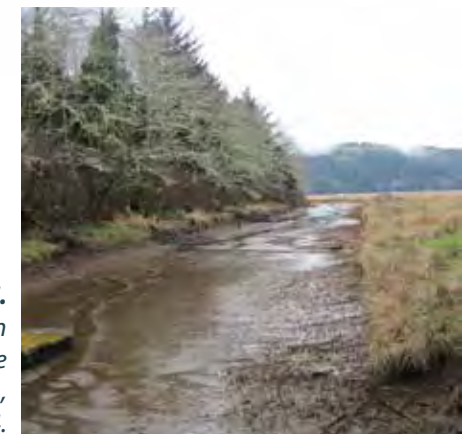
The 60-foot wide ditch (*Figure 67*) had altered the hydrology of the nearby area. Mink Creek was diverted into the ditch. A tributary parallel to the Salmon River was cut by the north-south leg

Figure 67. Boat Basin ditch before restoration, May 2014.

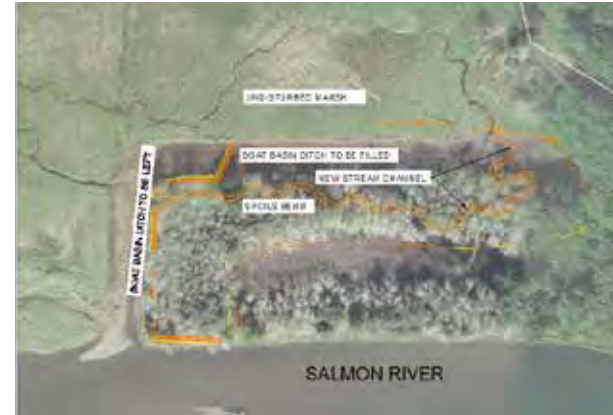
Figure 70

Figure 70. Proposed work shown with a Google Earth image as the background.

The option finally chosen was to remove the berm and the trees growing on it. Then the berm material was used to fill in the ditch and a new channel for Mink Creek was constructed over the location of the parallel tributary (Figure 66 and 70). The large amount of wood removed from the berm was used to reinforce the end of the fill material in the ditch and was then scattered on site.

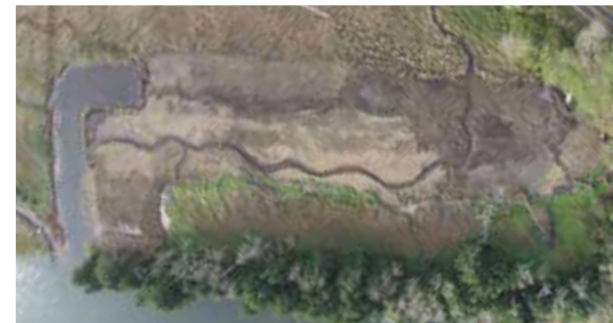
Figure 71

Figure 71. Aerial photo after restoration. October 10, 2014. Photo credit Grayson Lewis.

Next, we constructed a dam across the Boat Basin ditch and reinforced it with large woody material from the berm. The berm fill material was used to fill the ditch (Figure 73). Finally, we dug a new channel six feet wide for Mink Creek (Figure 71, 74-76 and 79). Figures 77 and 78 show the first incoming tide at 9:00pm on August 6, 2014.

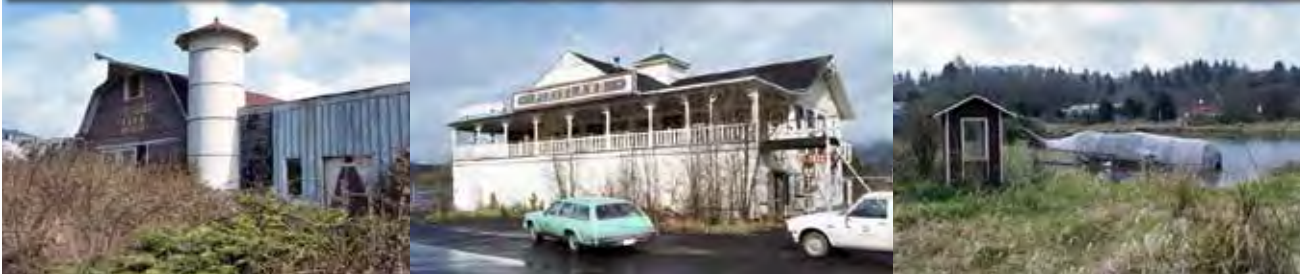
Figure 120

Figure 120. Photo trio of Pixieland in 1984 showing the Dairy Gold barn on Main Street, the train depot and the whale fountain all in disrepair following 1981 bankruptcy.

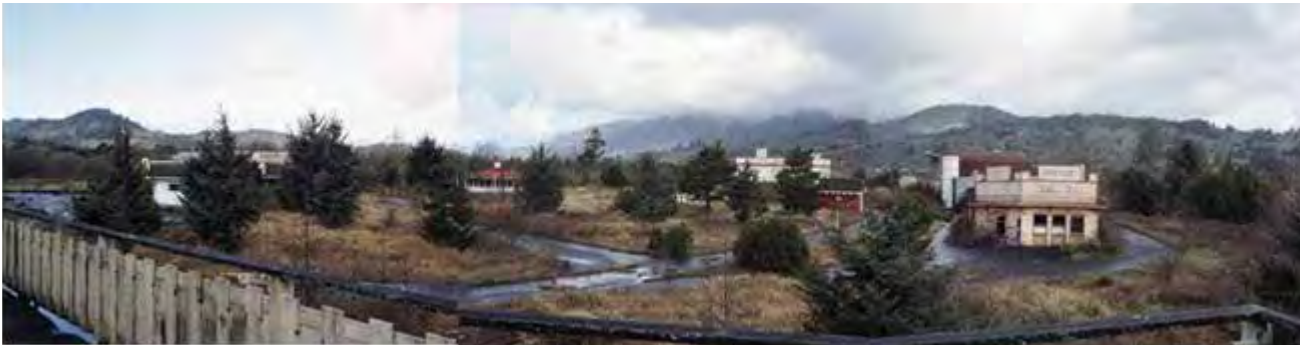
Figure 121

Figure 121. Pixieland in 1984. Looking Northwest toward Cascade Head in the distance.

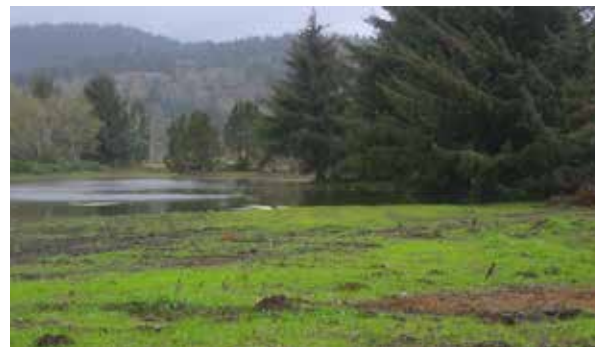
Figure 122

Figure 122. Main Street, Pixieland just after the restoration 2011.
